Dog Head Fire Private Land Fuel Treatment Effectiveness

Introduction

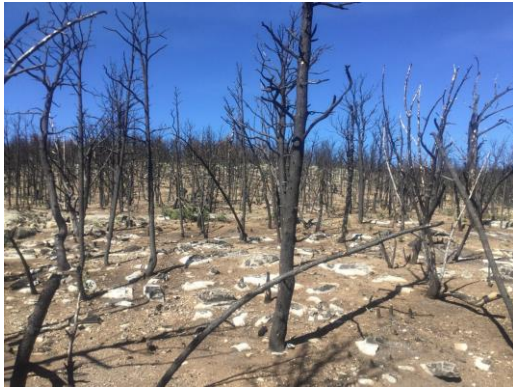
Untreated pinon-juniper woodland

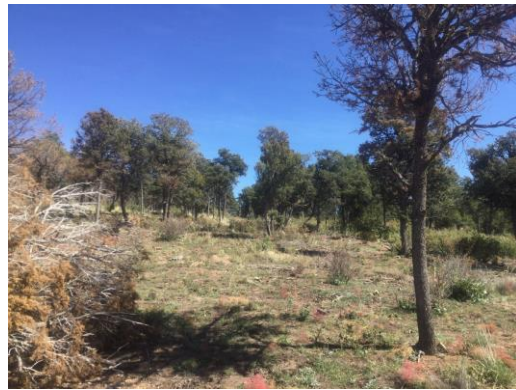
Treated pinon-juniper 0.08 miles away

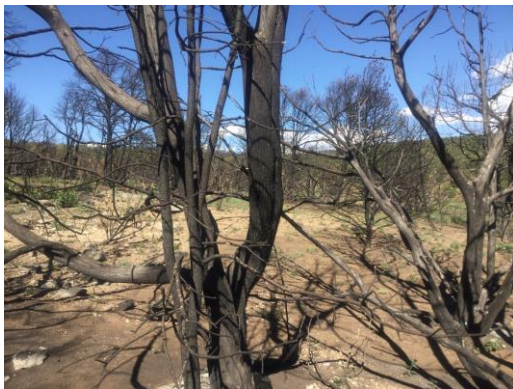
Untreated pinon-juniper woodland

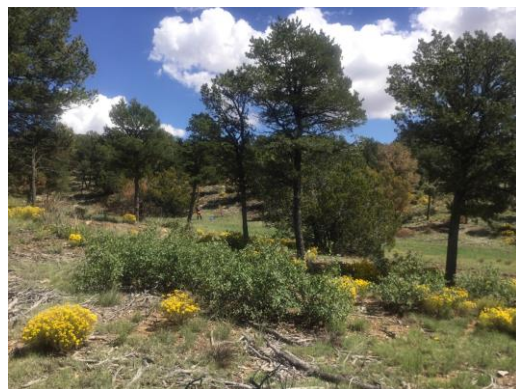
Treated pinon-juniper 0.34 miles away

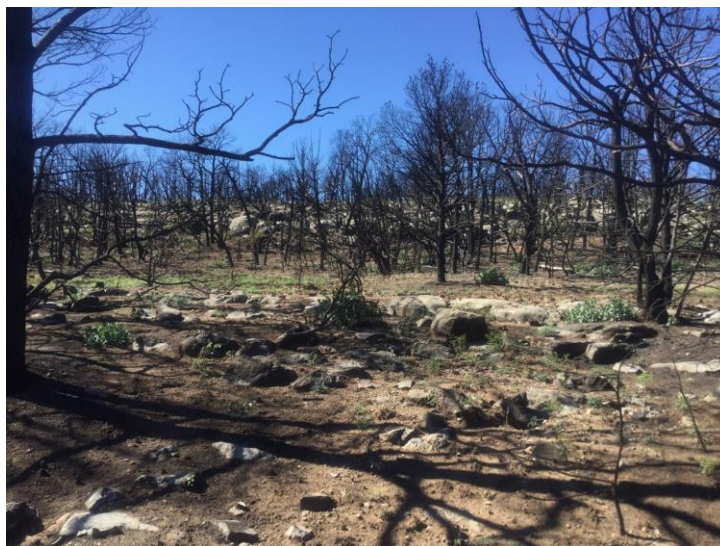
Figure 1. Untreated, burned stand

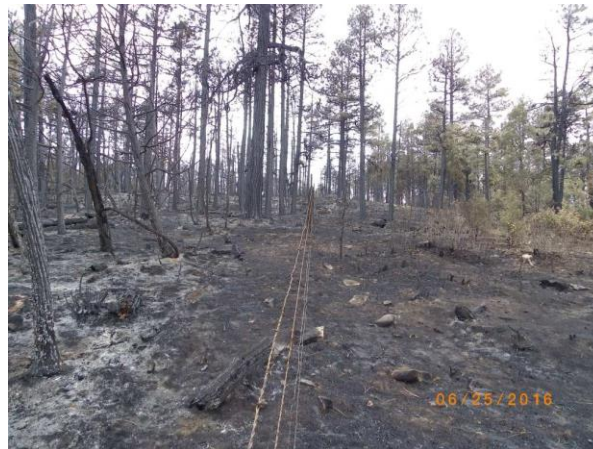
Most fuel reduction treatments on private land were positioned along the flanks of the fire but two treatments on the Chilili Land Grant were directly in the line of fire. The flaming front reached the Chilili treatments on the second day of the fire, June 15th. The treatments had similar prescriptions in terms of tree density but on one of the projects, the slash had been hauled off-site (Figure 2). Slash on the second project was left scattered throughout the site. Fire effects in the scattered slash site were similar to adjacent, untreated areas and the site supported an active crown fire. In contrast, the site with slash removal performed relatively well. Tree mortality was lower in the treated stand than in the adjacent untreated forest on U.S. Forest Service property (Figure 3). Although the fire still burned hot through the treated stand, the reduced canopy bulk density within the treated stand appears to have limited crown fire activity. It should be noted, however, that the fire severity within these stands also corresponded with respective differences on the surrounding land.

Figure 3. Treated Chilili forest on right and untreated USFS land on left (Courtesy Edgewood SWCD)

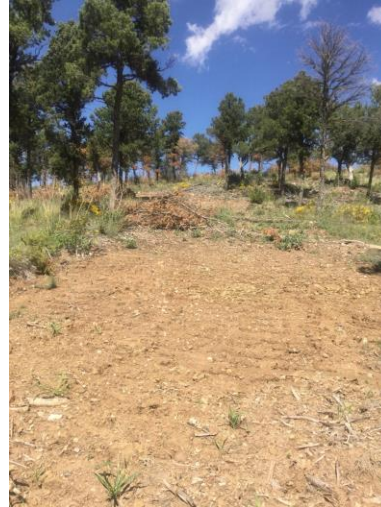
Meadow openings and reduced tree density consistently provided sites for firefighters to construct fire line, either by hand or with a bulldozer (Figure 4).

Figure 4. Dozer line constructed within thinned forest

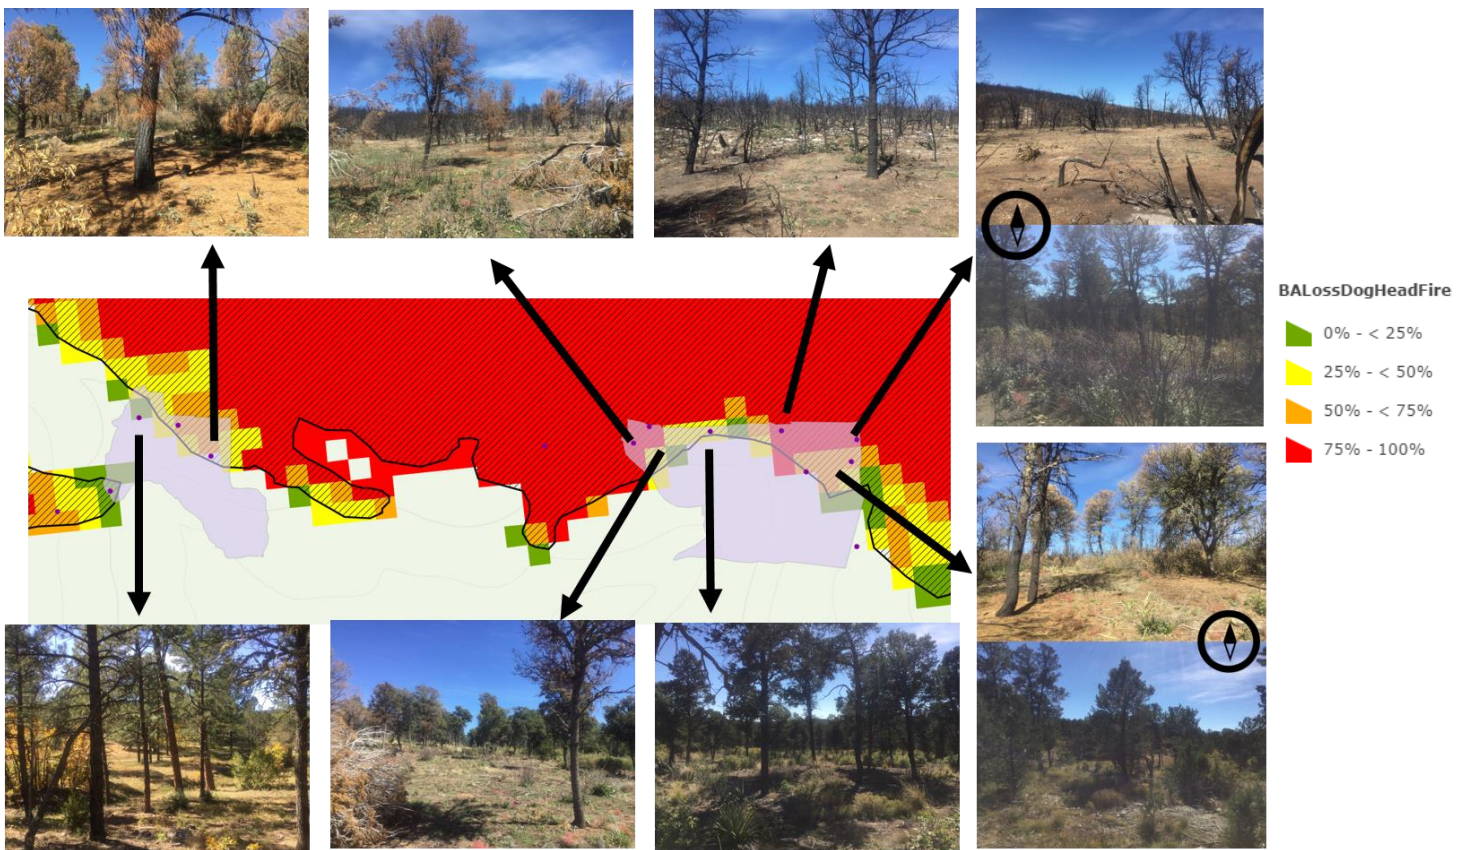
As expected, treatments along the fire flanks performed better than treatments located at the head of the fire. Along the southern flank, the combined effects of fire line construction and reduced tree density within treated stands produced stark differences in tree mortality and fire severity north of the project boundaries (Figure 5). Red areas on the map indicate a live tree density reduction of 75-100%.

Figure 5. Photos contrasting burned areas north of treatments with treated stands.

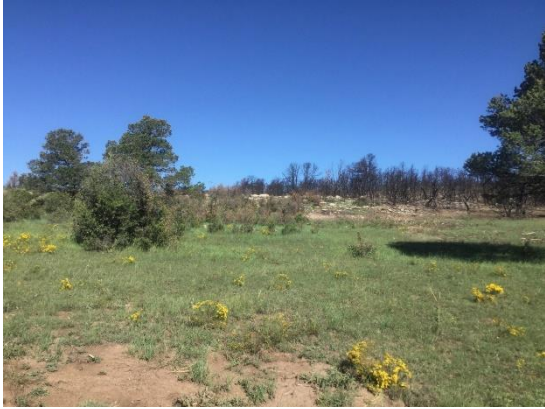
Several of the fuel reduction treatments included meadow restoration. These meadows consistently provided effective fuel breaks that limited fire spread (Figures 6 & 7).

Figure 7. Standing in restored meadow on eastern fire boundary, looking at untreated, burned woodland

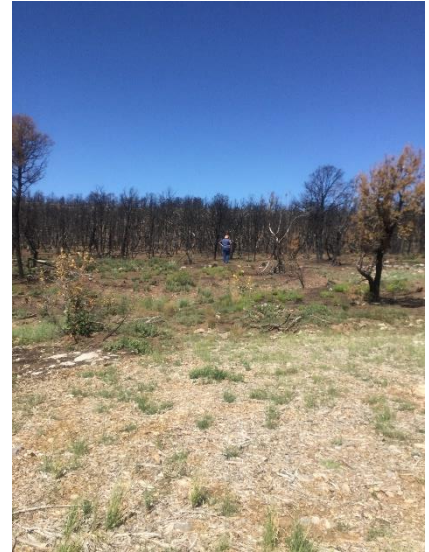
Figure 6. Looking north from restored meadow on southern flank of fire

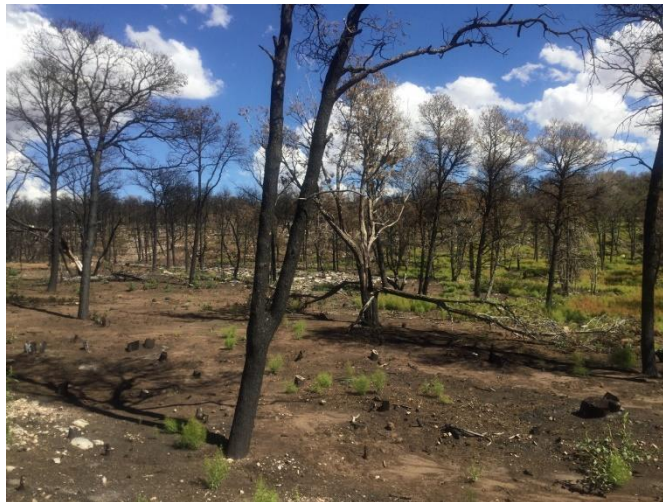
In addition to reduced tree mortality in treated stands, soils also were apparently less severely impacted. Recovery of grasses and forbs is taking place within treated areas while adjacent untreated sites often have little growth (Figure 8). Generally, treated sites were greener than adjacent untreated areas.

Figure 8. Plant recovery within treated stand on right compared to untreated area on left

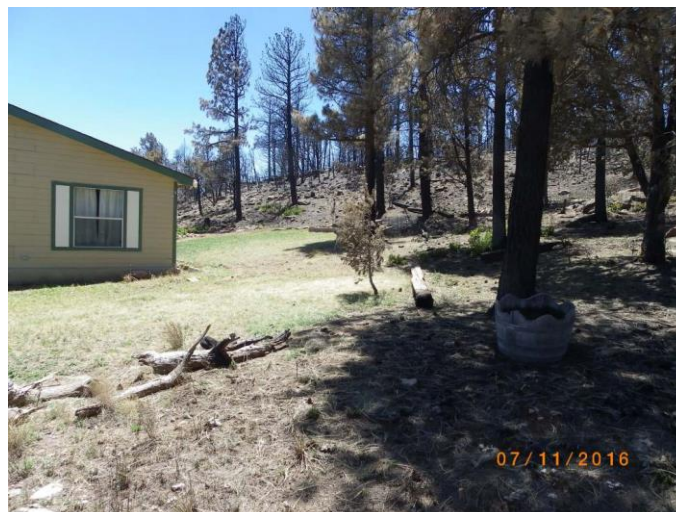
Most of the structural losses occurred along Aceves Road on the east side of the fire. Despite catastrophic losses surrounding the property, one home was likely saved as a result of a defensible space treatment that was completed in 2008 (purple polygon in Figure 9). The project was less than 3 acres but the lack of ladder fuels and reduced tree density helped protect the home (Figure 10). The fire was hot enough to melt the plastic gutters but the defensible space was adequate to prevent structural ignition.

Figure 9. Intact residence with burned ponderosa forest (Photo courtesy of Edgewood SWCD)
