Dog Head Fire Private Land Fuel Treatment Effectiveness

Introduction

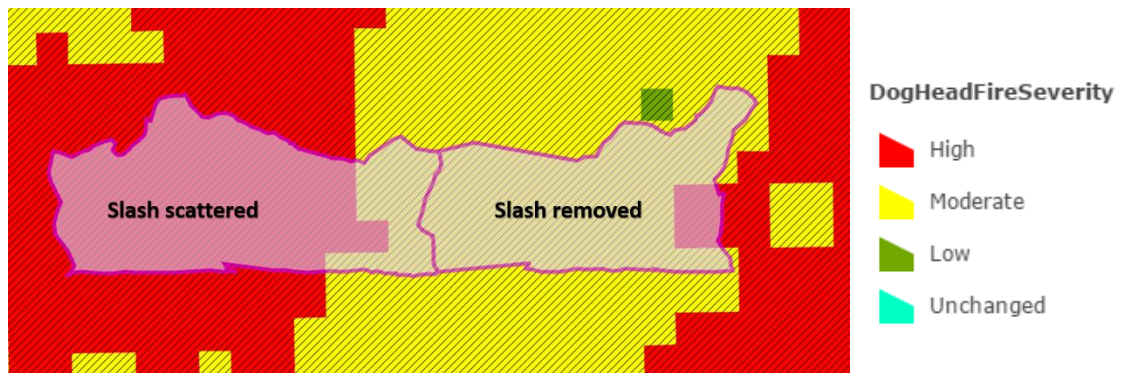
Figure 2. Chilili project boundaries and fire severity

Most fuel reduction treatments on private land were positioned along the flanks of the fire but two treatments on the Chilili Land Grant were directly in the line of fire. The flaming front reached the Chilili treatments on the second day of the fire, June 15th. The treatments had similar prescriptions in terms of tree density but on one of the projects, the slash had been hauled off-site (Figure 2). Slash on the second project was left scattered throughout the site. Fire effects in the scattered slash site were similar to adjacent, untreated areas and the site supported an active crown fire. In contrast, the site with slash removal performed relatively well. Tree mortality was lower in the treated stand than in the adjacent untreated forest on U.S. Forest Service property (Figure 3). Although the fire still burned hot through the treated stand, the reduced canopy bulk density within the treated stand appears to have limited crown fire activity. It should be noted, however, that the fire severity within these stands also corresponded with respective differences on the surrounding land.

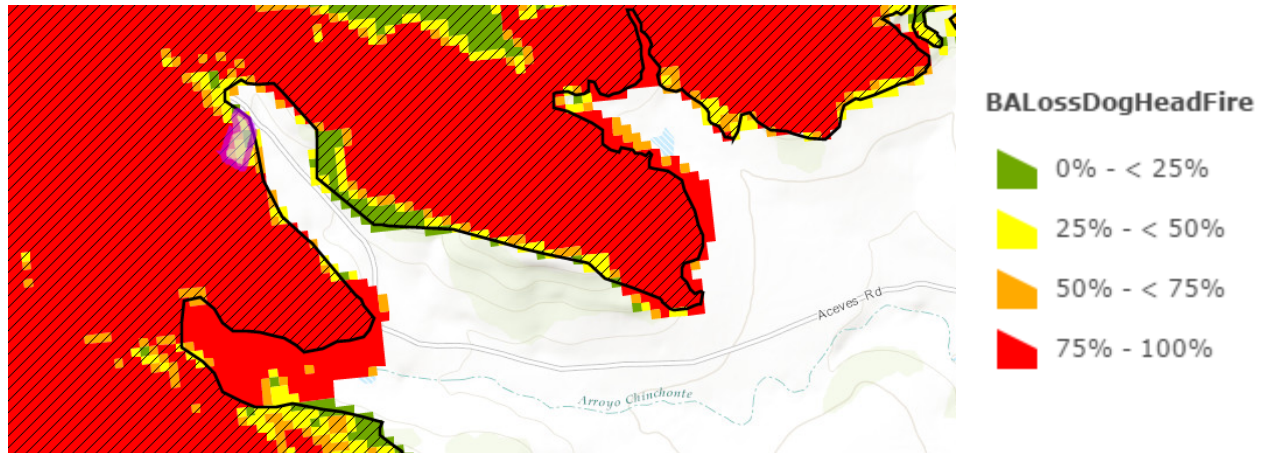
Figure 10. Fire severity surrounding treated property on Aceves Road

Most of the structural losses occurred along Aceves Road on the east side of the fire. Despite catastrophic losses surrounding the property, one home was likely saved as a result of a defensible space treatment that was completed in 2008 (purple polygon in Figure 9). The project was less than 3 acres but the lack of ladder fuels and reduced tree density helped protect the home (Figure 10). The fire was hot enough to melt the plastic gutters but the defensible space was adequate to prevent structural ignition.

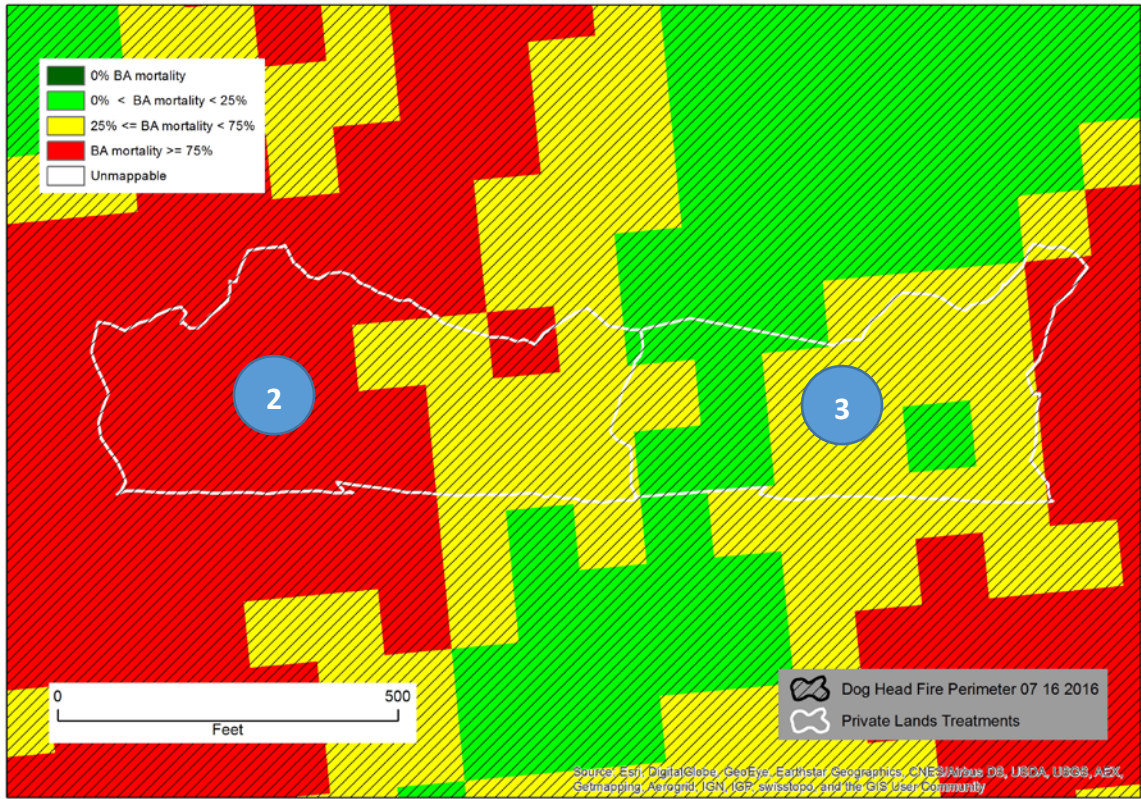
Basal Area Loss, Chilili 2009

9.68	2011	yes	39.5	Unchanged and low	Fire effects appear to be associated with accumulations of fuel following mastication.	6
		7.63	2010	yes	65.0	Unchanged	Northwest treatment boundary is burn boundary.	None
Wright	ESWCD	2.91	2010	yes	43.3	Moderate, unchanged, and low	Defensible space treatment and ponderosa pine thinning may have prevented structural ignition.	4
Chilili Land Grant	ESWCD	4.87	2008	no	47.5	High	Slash scattered	2

3.81	2008	no	47.5	Moderate	Slash removed	3
